### **ANALYSIS OF NON-BUOYANT LOBSTER LINES NEW, USED AND MACHINE TESTED**

**Visual Examination  
Microscopic Examination  
Rope and Yarn Strength Testing  
Scanning Electron Microscopy**

**Massachusetts Division of Marine Fisheries  
and  
Atlantic Offshore Lobstermen's Association**

**May 17, 2006**

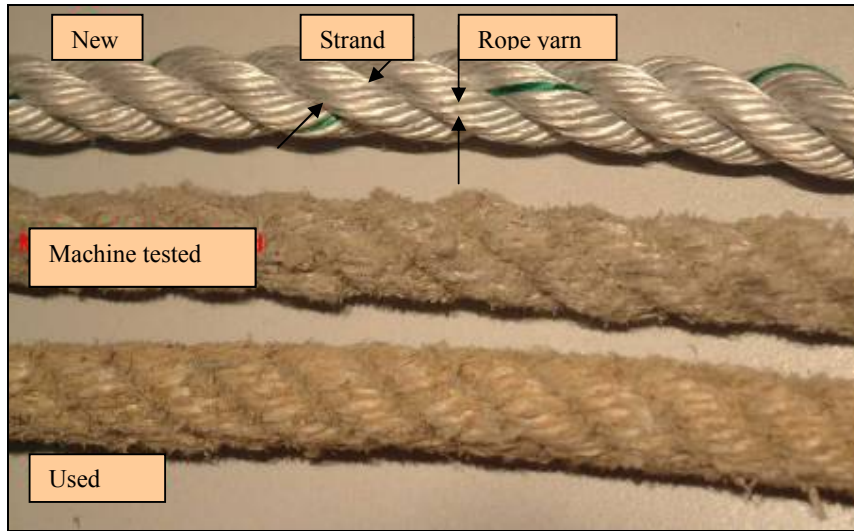
**Figure 6** Close view of L1 new, used and machine tested samples.  
Note that each strand is constructed from multiple rope yarns.

It may be seen that there is a difference in appearance between the machine tested and used samples, with the machine tested sample appearing to be more abraded.

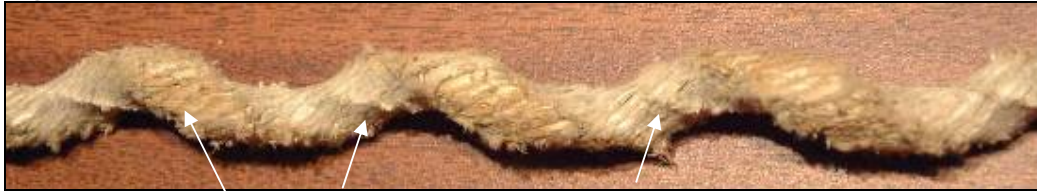
**Figure 8** Close view of a used strand

Both external and internal abrasion is seen. Ridge caused by adjacent strand pressure.

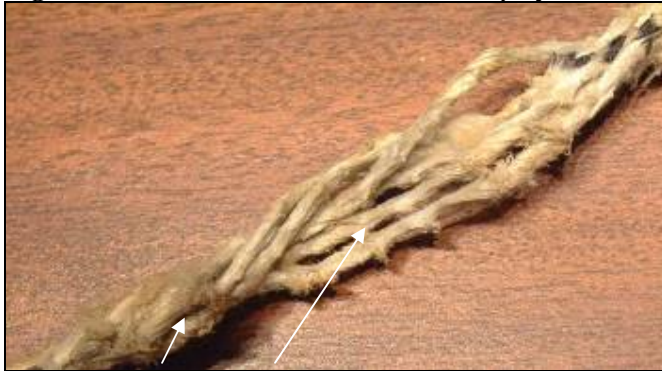
**Figure 9** L1 Close view of used outer rope yarns

The result of external and internal abrasion is clearly seen. Internal fiber abrasion is less than external

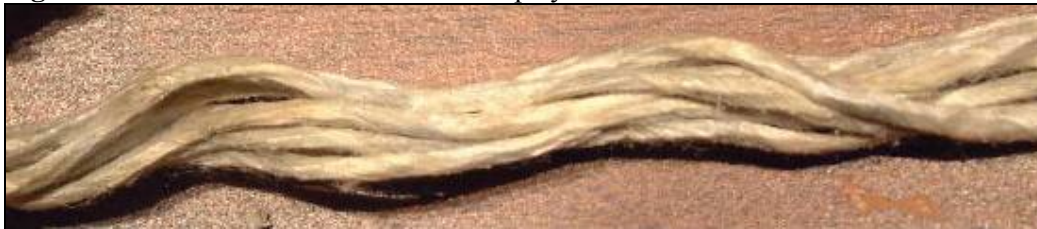
**Figure 10** L1 Close view of used inner rope yarns

**Photo note:** Inner rope yarns are in the center of the stand and do not come to the surface . The condition of these rope inner yarns is clearly better than the outer rope yarns (photo above)

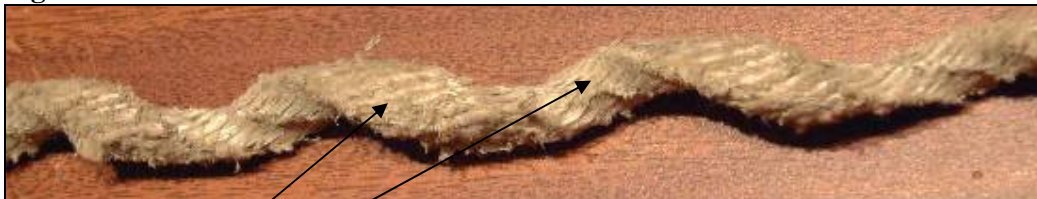
**Figure 11** L1 Close view of machine tested strand

**Photo note:** Both external and internal abrasion damage is seen

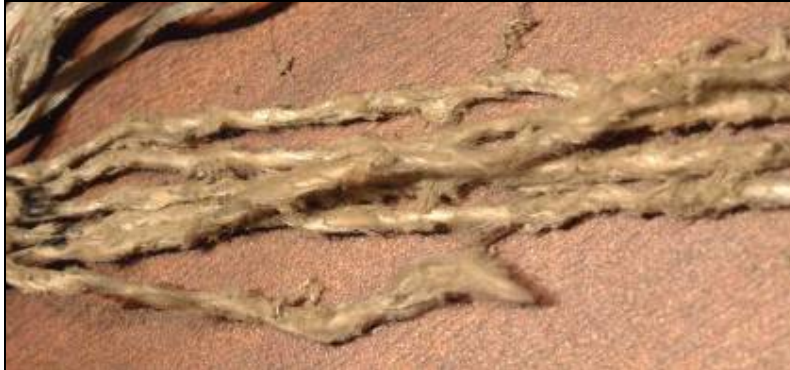
**Figure 12** L1 Close view of machine tested outer rope yarns

**Photo note:** Abrasion damage is seen, with one rope yarn completely severed

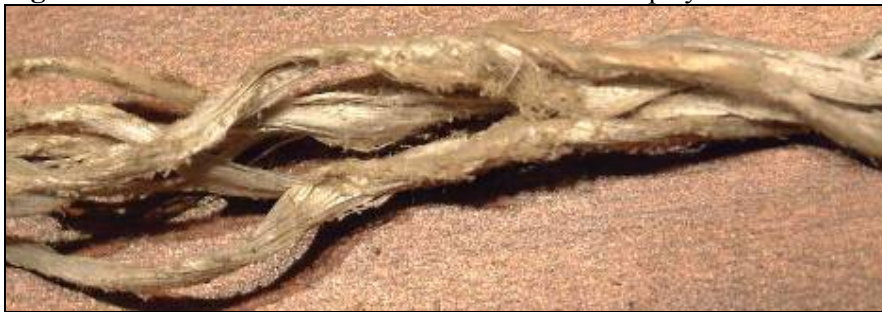
**Figure 13** L1 Close view of machine tested inner rope yarns

When comparing the machine tested (above) and used conditions, photos (figures above) it is seen that the poorer appearance of the machine tested rope is reflected in the higher degree of abrasion damage seen at the rope yarn level. Although the service conditions of the used rope are unknown, it may be speculated that the mechanical effects of the machine testing is more severe.

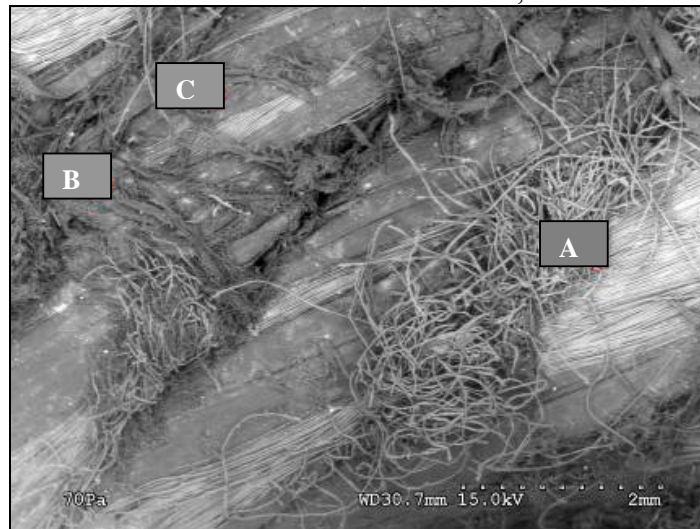
**Figure 16 L1 Machine Tested -General view, outer face of strand**

The thick monofilament polypropylene [PP] and fine multifilament polyester [PET] components of the strand are immediately seen. In general, the finer, intact, PET filament material, is lighter in color (naturally white) although the tangled PET filaments appear dark due to contamination, such as rust or dirt.

Broken and tangled PET filaments are obvious at 'A'. At 'B' there is abraded and fibrillated material, assumed to be from the PP monofilament component. Amongst the filaments, sediment particles may be seen, showing as white dots or spots. From the scale shown on the photograph, the larger particles are about 100 micron, whilst the smallest ones are less than 10 micron.

At 'C', there is an example of a monofilament that has been so severely abraded that just a layer of it remains, overlying the PET filaments beneath. The underlying filaments can be seen throughout the remaining PP material.

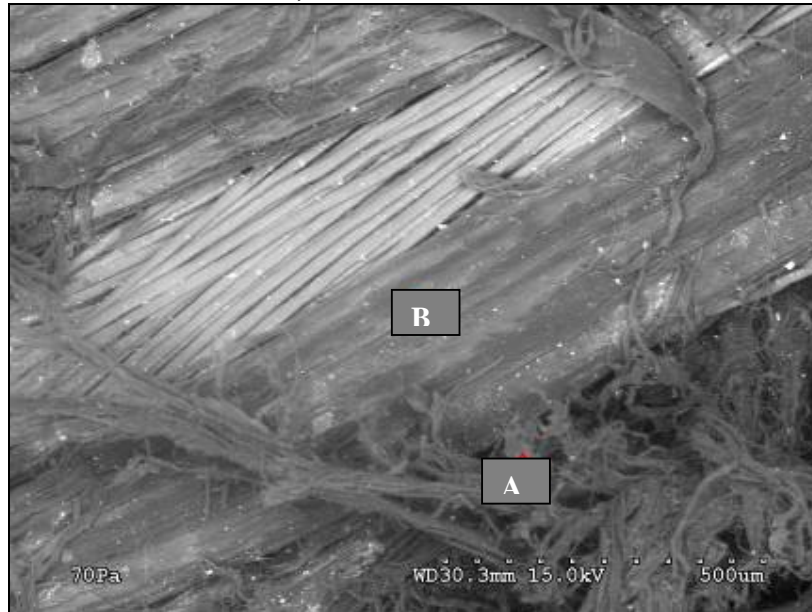
**Figure 17** L1 Machine Tested  
Close view of abraded PP, outer face of strand

At 'A', fibrillated PP material, the result of abrasion, is seen, whilst at 'B' the remains of a PP monofilament is seen.

The PET filaments appear in reasonable condition, despite the severe damage seen on the PP material. There is some evidence of short grooves on the surface of some of the PET filaments that may well be the result of abrasion caused by particles. The damage to the PP does not appear to have been caused by particles, the more likely source of this damage is surface abrasion caused by winding of the ropes by winches.

Sediment particles, the majority circa 10 micron, are seen on both the PP and PET filaments.

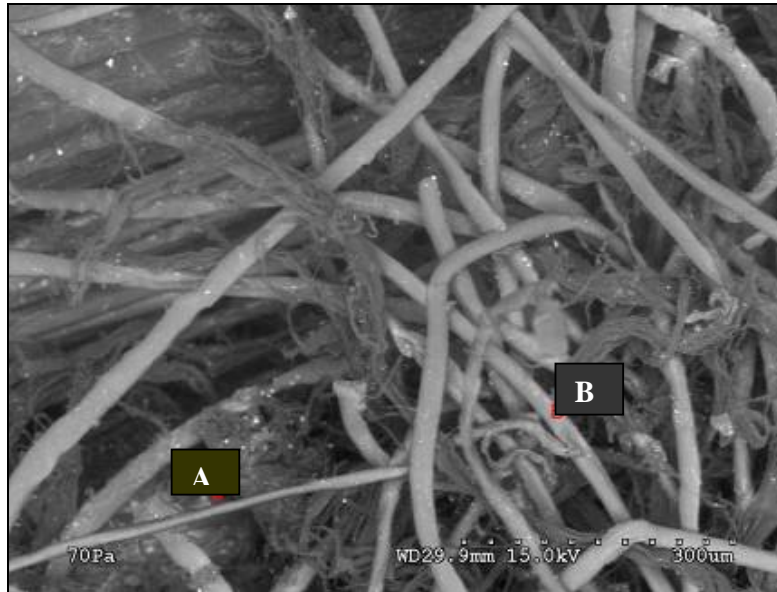
**Photograph 18** L1 Machine Tested - Close view of damaged PP and PET, outer face of strand

Flattening of the PET filaments is seen on this photograph, as shown at 'A'.

At 'B', there is a large groove on a PET filament. There are no large sediment particles in the vicinity, and this damage is more likely to have been caused by filament-filament abrasion. Fibrillated PP debris [ the darker tangled masses] is also in evidence.

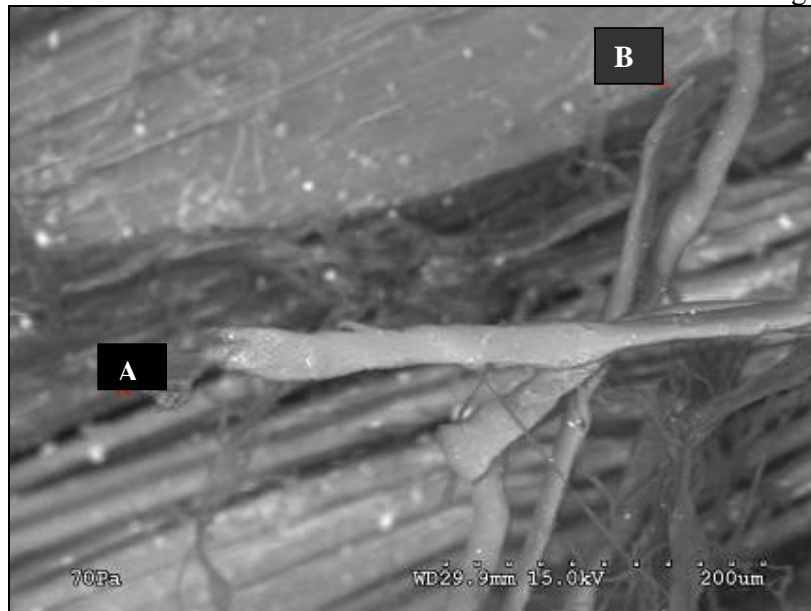
**Figure 19** L1 Machine Tested - View of outer filament failure B of Photograph 17

The failed end is clearly seen at 'A', with severe flattening to the upper surface of the filament. At 'B', another failed end is seen, but there appears to be very localized twisting in the failure zone. Flattening of a filament would not be caused by sediment abrasion.

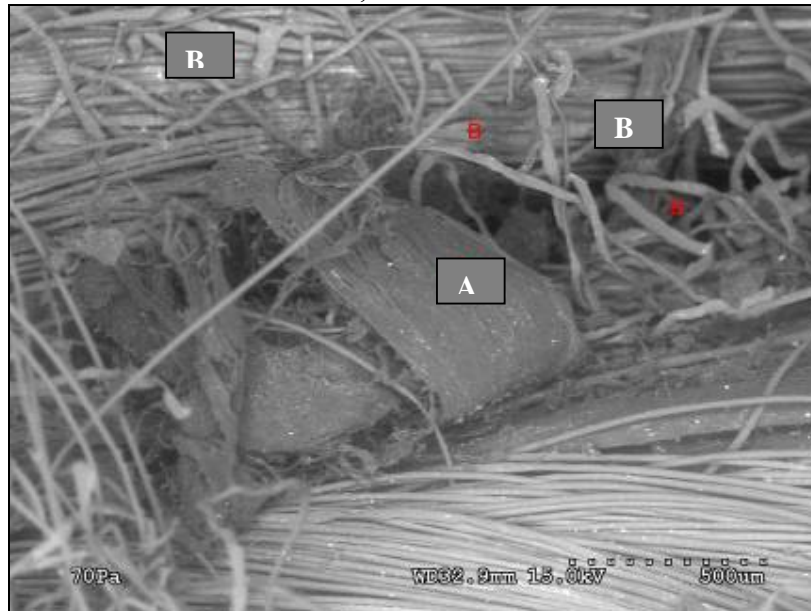
**Photograph 20** L1 Machine Tested  
Close view, inner face of strand

At 'A', the PP filament has partially failed under tension. The result is a lash back mechanism that causes the failed material to be out-of-plane with respect to the remainder of the filament. The partial failure was most likely initiated by localized flex-fatigue of an abraded part of the filament.

Sediment particles are seen throughout the photograph, but particularly on the under-face of the failure 'A'. This is evidence that the filament had suffered surface damage before the particles were present, as there could be no way for them to penetrate the internal structure if the filament surface was undamaged.

Flattened PET filaments are seen at 'B'.

A significant proportion of the PET filaments appear in reasonable condition, as seen to the bottom right hand side of the photograph.

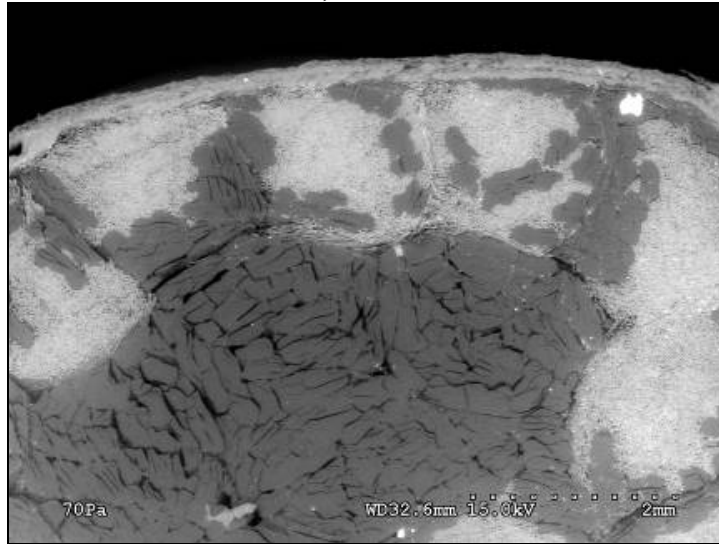
**Photograph 21** L1 Machine Tested  
General view, strand cross-section

The minimum magnification of  $\times 18$  was used, but the sample was too big to allow a complete view of the cross section. It can be seen however that there is an outer layer of yarns, consisting of an assembly of monofilament PP and multifilament PET. This outer layer surrounds an inner core of monofilament PP.

A very large particle is seen towards the top right of the image, and is probably entered during the sample preparation.

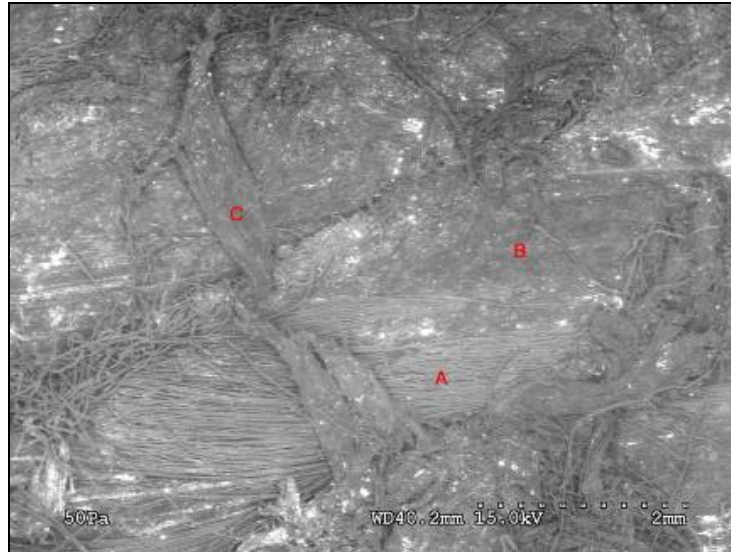
**Photograph 22 L1 Used rope**  
General view of outer face

A multifilament PET yarn is seen at A [ broken filament are also seen]; a monofilament PP yarn at B; and damaged monofilament at C. Particle contamination is readily seen as white areas in the image. Compared to Photograph 2, L1 machine tested outer surface, the particle contamination is greater for the used rope.

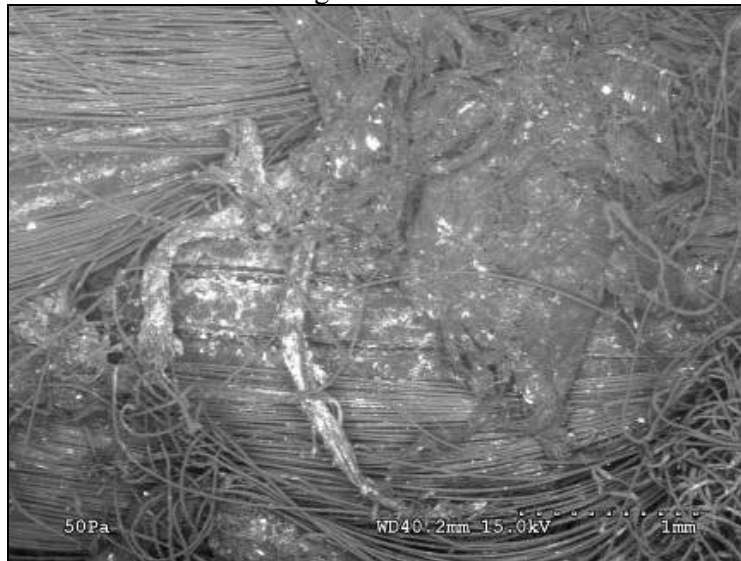
**Photograph 23 L1 Used rope**  
Another view of damaged and contaminated outer face

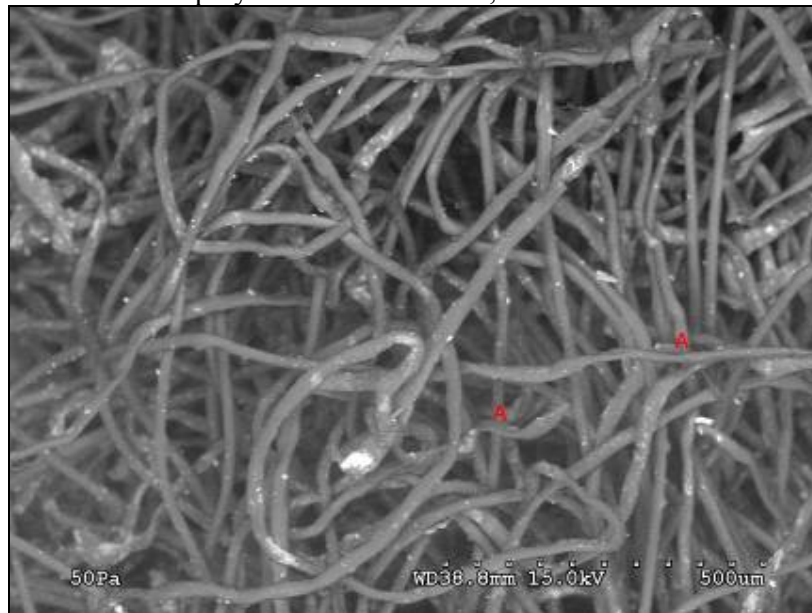
**Photograph 24 L1 Used rope**  
Flattened polyester multifilaments, outer face

Flattening is seen at A, but it is seen over the whole image. Compared to Photograph 4, L1 machine tested, the severity of flattening is less, suggesting that that the machine testing creates more pressure on the rope.

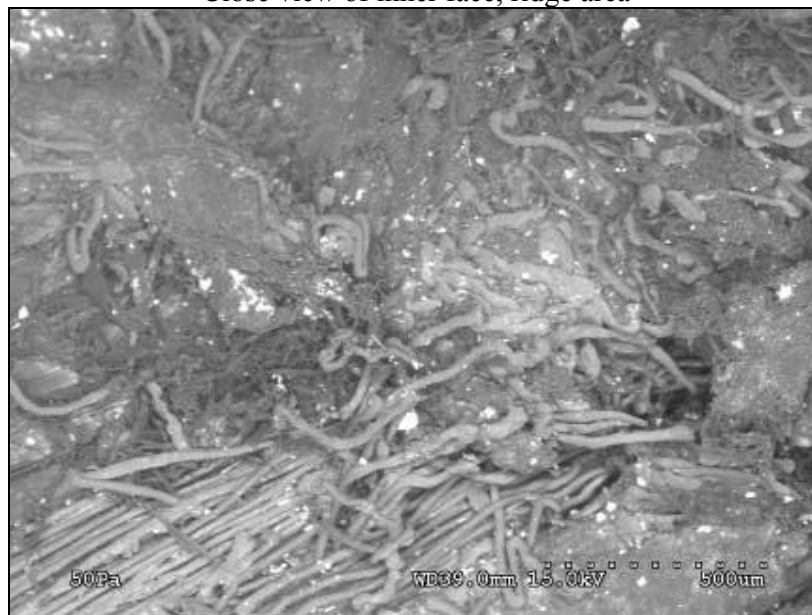
**Photograph 25 L1 Used rope**  
Close view of inner face, ridge area

Flattened polyester filament debris embedded in fibrillated PP are seen. Particle sizes are 50 micron and less are also seen in this image.

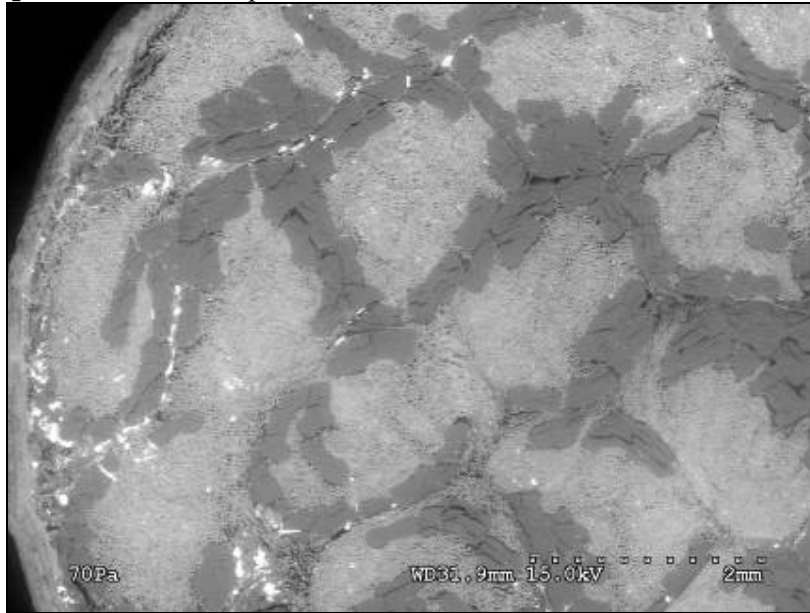
**Photograph 26** L1 Used rope General view, cross-section

It may be seen that the strand is constructed differently from the strands used in the machine tested rope, in that there is no evidence of an inner core of monofilament PP.

In the image above, the migration path for sediment particles is seen to follow the outside of a rope yarn, where the PP monofilaments form the outer layer. Migration of particles into the multifilament PET is comparatively small.

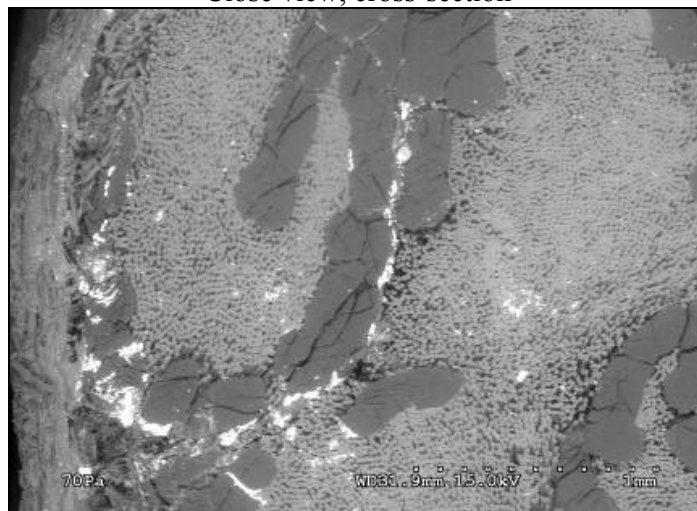
**Photograph 27** L1 Used rope  
Close view, cross-section

The migration path is seen, though some clusters of particles are seen within the PET filaments.

There appears to be a tendency for sediment particles to fill voids in the internal structure of the PP filaments and along the boundary. It is suggested that these voids are created by a delamination mechanism that has its origin in flex fatigue. However,

The diameters of the filament components are the same as for the machine tested rope. It is difficult to determine if the sediments, seen as the white areas, are agglomerations of smaller particles, though it would be expected that this is the case.
